Metso

Three common chute lining challenges and how to solve them

Expert advice to prevent downtime
and improve performance

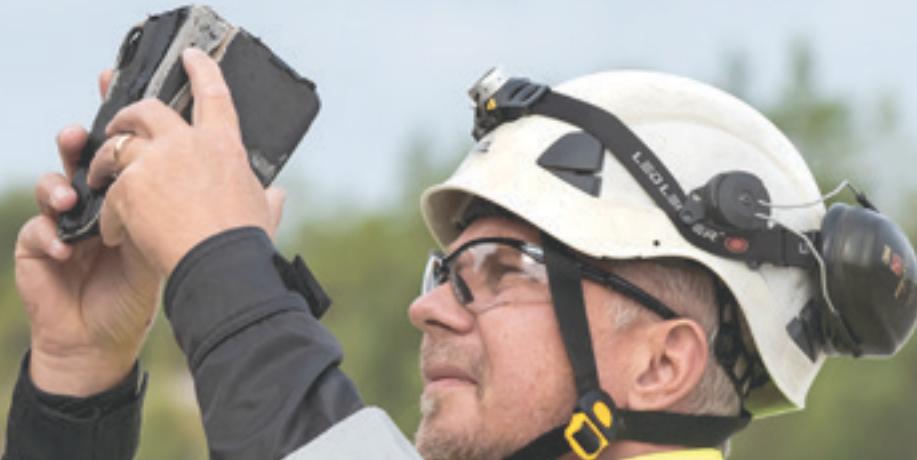
Noise isn't just an annoyance, it's a serious issue in material handling. The combination of impact, vibration and material transfer inside chutes may result in sound levels exceeding healthy and permissible limits. This issue goes beyond operator well-being; reducing noise is essential for creating a safer, more efficient work environment that sustains productivity and minimizes the risk of regulatory complications.

Our approach is to target noise at its source. Instead of relying on external barriers, we design chutes that absorb impact energy and reduce vibration through smart geometry and liner material selection. Rubber and composite liners act as natural dampers, while optimized flow paths minimize sudden impacts. For critical applications, we can integrate acoustic modeling and vibration analysis to predict noise levels before installation.

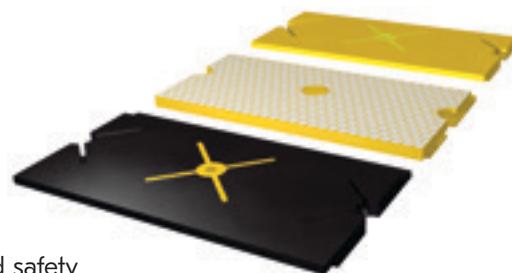
Trellex® SQ 300 polyurethane

A high-performance wear protection system that reduces impacts and improves health and safety in a variety of important ways – all without increasing costs or sacrificing operational efficiency. Trellex SQ 300 is designed for simple installation and minimal downtime, thanks to its patented fastening system. It can be easily cut to size using a knife or an aluminum-cutting machine.
